# TECHNICAL INFORMATION

## TV EQUIPED OF ICC19 CHASSIS (50Hz and 100Hz)

ICC19 16/9 50Hz CHASSIS →

- 32WS88KE
- 32WS83KP
- 28WS73KD
- 28WS78KE

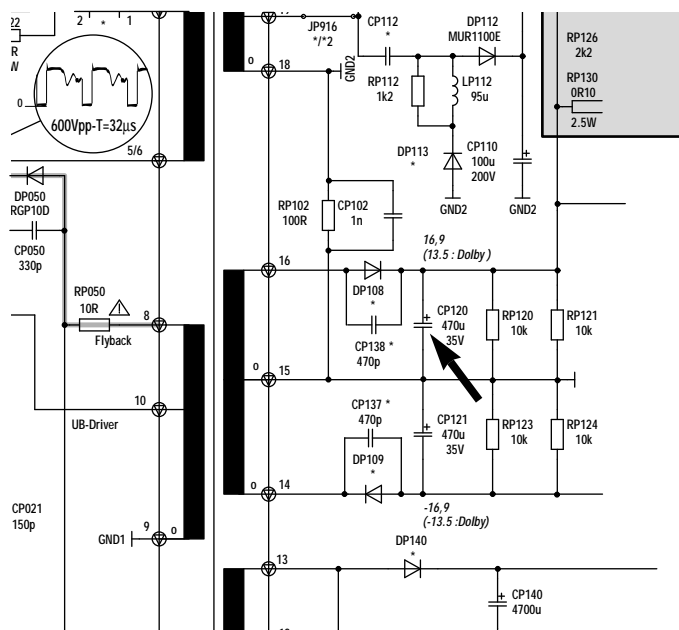
When the television is in the Standby Mode, residual noise can be heard from the loudspeakers.

Change CP120 from 470 $\mu$ F 35V to 330 $\mu$ F 25V capacitor (codice 10448410)

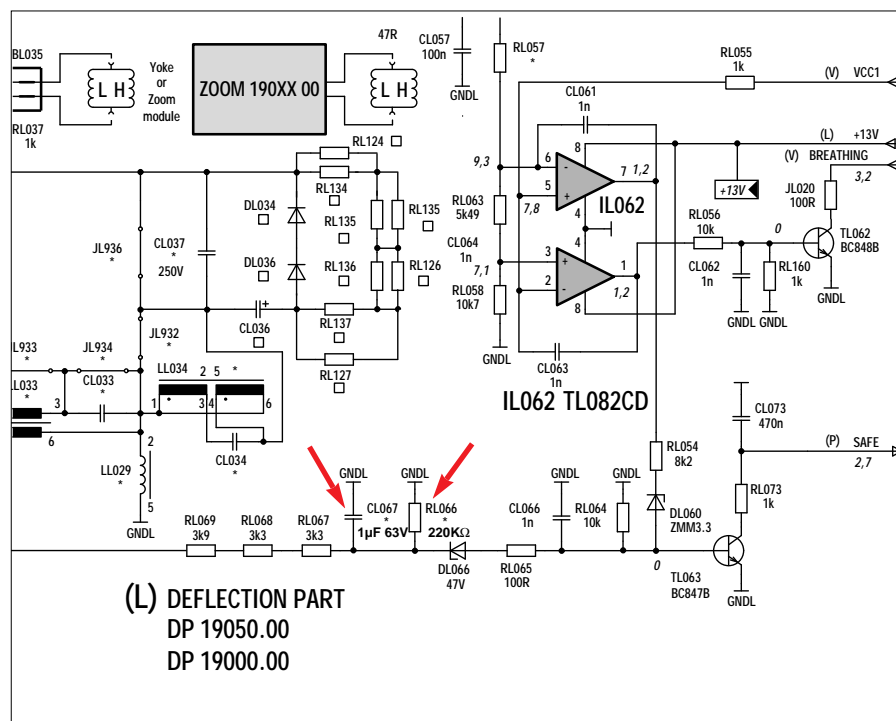
Power supply switches to safety mode during VCR operating.

Loss of synchronisation signal for 1 or 2 frames (poor quality video recording).

- Replace capacitor CL067 (100nF 100V) with a 1μF 63V (Part No. 43067772).
- Add a 220kΩ 5% 100mW melf resistor at position RL066 (Part No. 10328700)
